# Engineering investigation report

Kamarooka Hall, 420 Kamarooka Store Road, KAMAROOKA, VIC 3570

## 1.0 Introduction

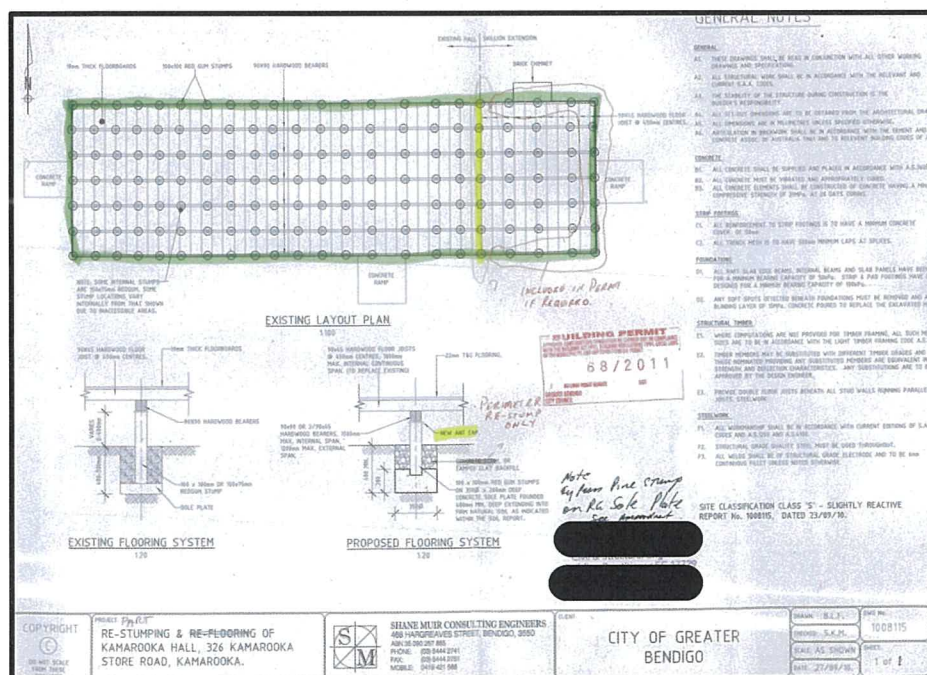
Figure 3.3 – Extract from a plan prepared by [REDACTED] dated 27 September 2010 indicating the re-stumping works to be conducted to the subject building.

- 3.17 Reviewed correspondence and renovation plans prepared by [REDACTED], dated September 2010, indicates that due to deterioration and sinking of the perimeter stumps, the external stumps and some floor bearers and joists were required to be removed and replaced; refer to Figures 3.2 and 3.3.

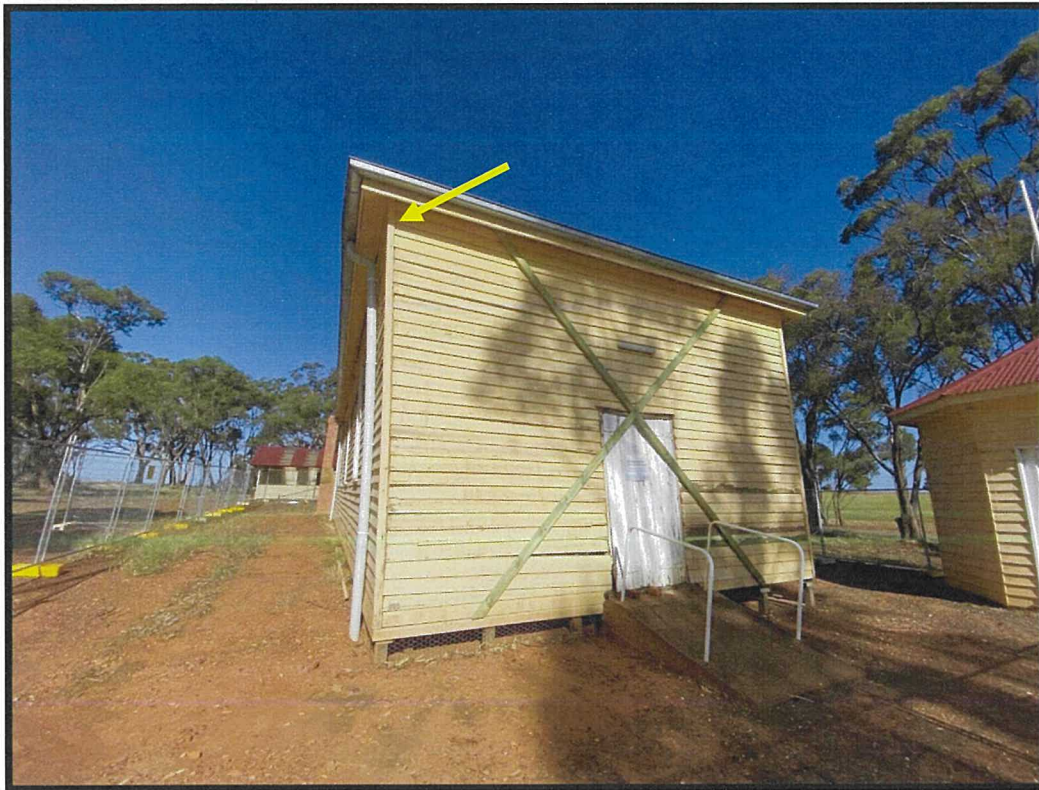
- The west end of the building is leaning towards the west by 3.2° (56mm/m) [1]. Refer to Appendix B for the inclination/leaning measured in other regions of the building.
- Temporary bracing has been installed as part of the make safe works [1].
- The ground immediately adjacent to the building perimeter is unsealed [1-2].
- Timber splitting, detachment/misalignment to the weatherboard cladding [3-4].
- Dilapidation to the window frames along the building perimeter including timber splitting and damaged to the sealing [5].
- Cracked dried soil surface adjacent to the building perimeter [6].

Photograph 1 – The west end of the building is leaning towards the west by  $3.2^\circ$  (56mm/m). Temporary bracing has been installed as part of the make safe works. Note the unsealed ground immediately adjacent to the building perimeter.

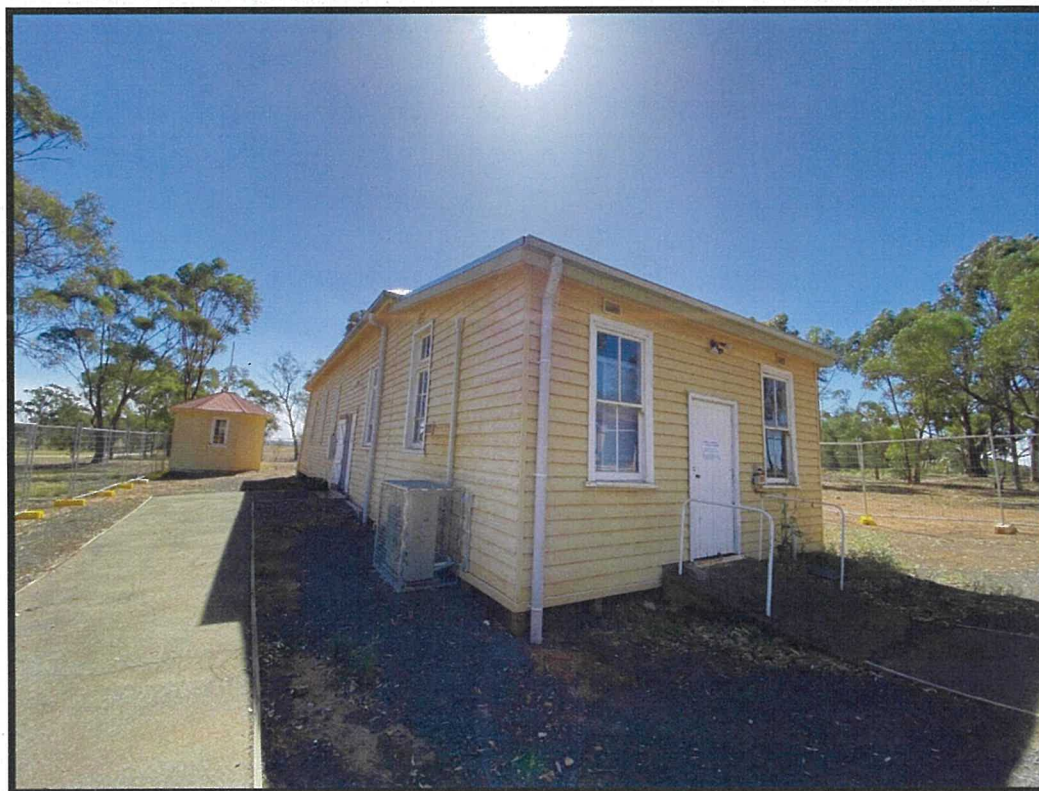
Photograph 2 – Overview of the southeast corner of the building. Note the unsealed ground immediately adjacent to the building perimeter.

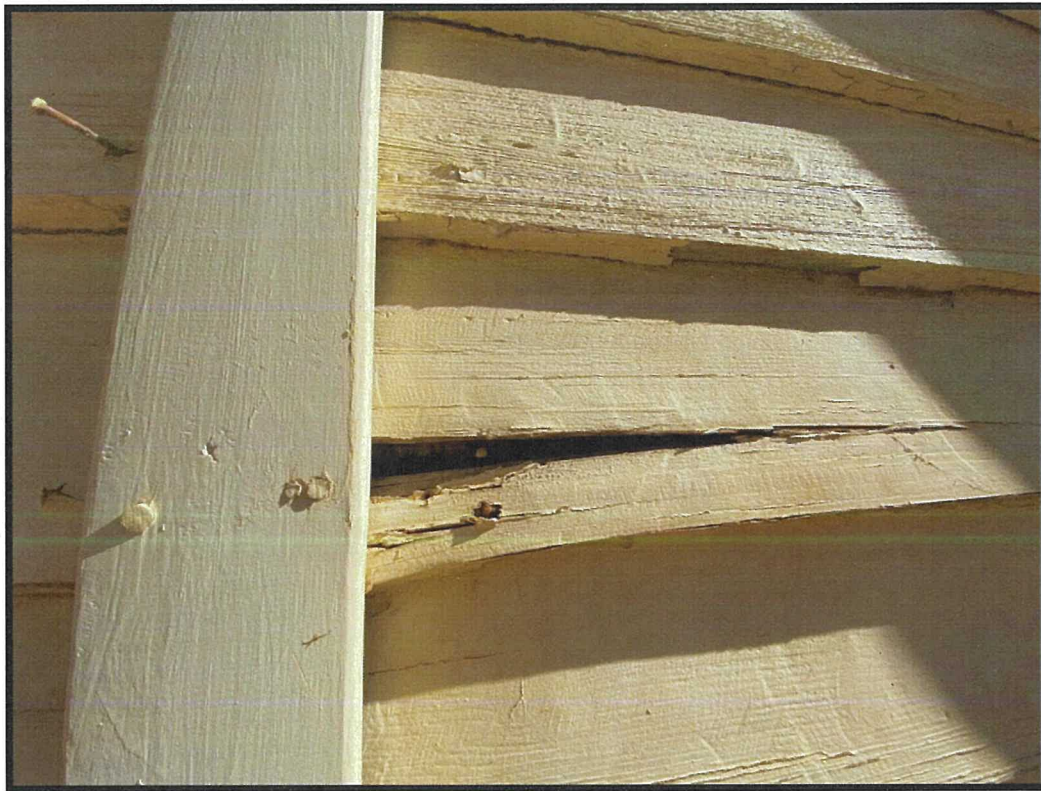
damage to building elements, previously reported circa 2017) has reduced the bracing capacity of the building walls. Note that the lack of adequate weatherproofing protection to the timber framing of walls is also expected to have contributed to accelerating the natural decay process of the timber wall members and, therefore, reducing the building's bracing capacity [3-5].

Photograph 3 – Timber splitting to the weatherboard cladding.

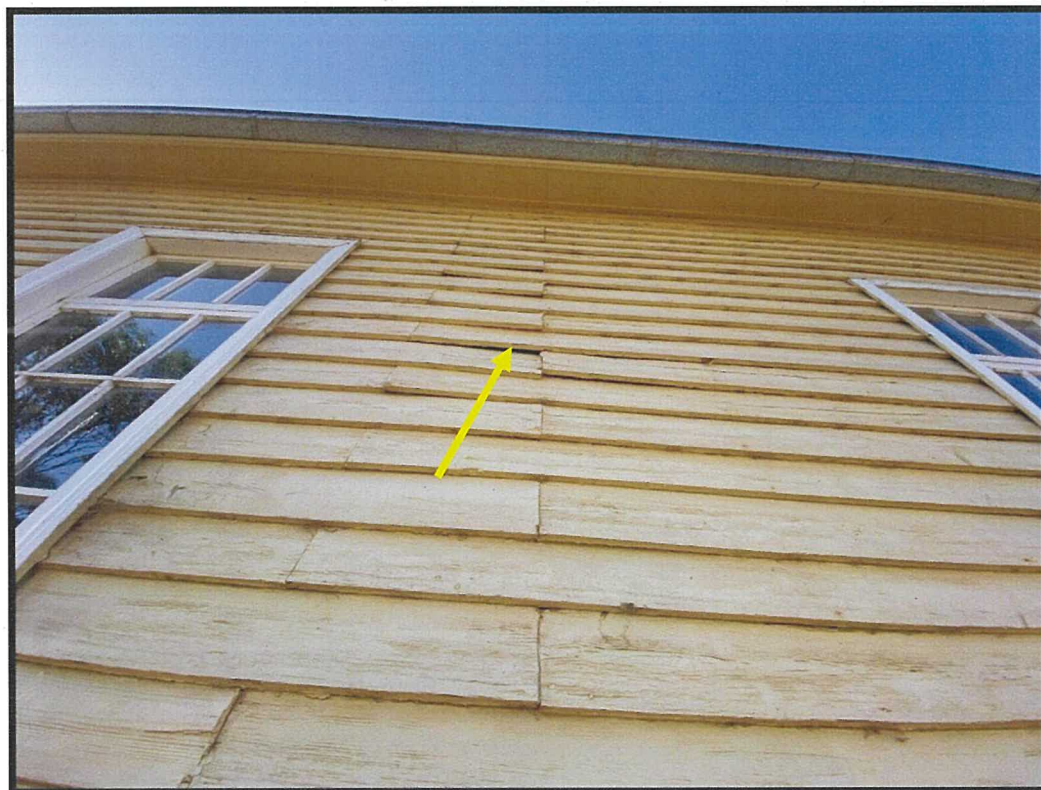
Photograph 4 – Typical splitting, detachment/misalignment to the weatherboard cladding.

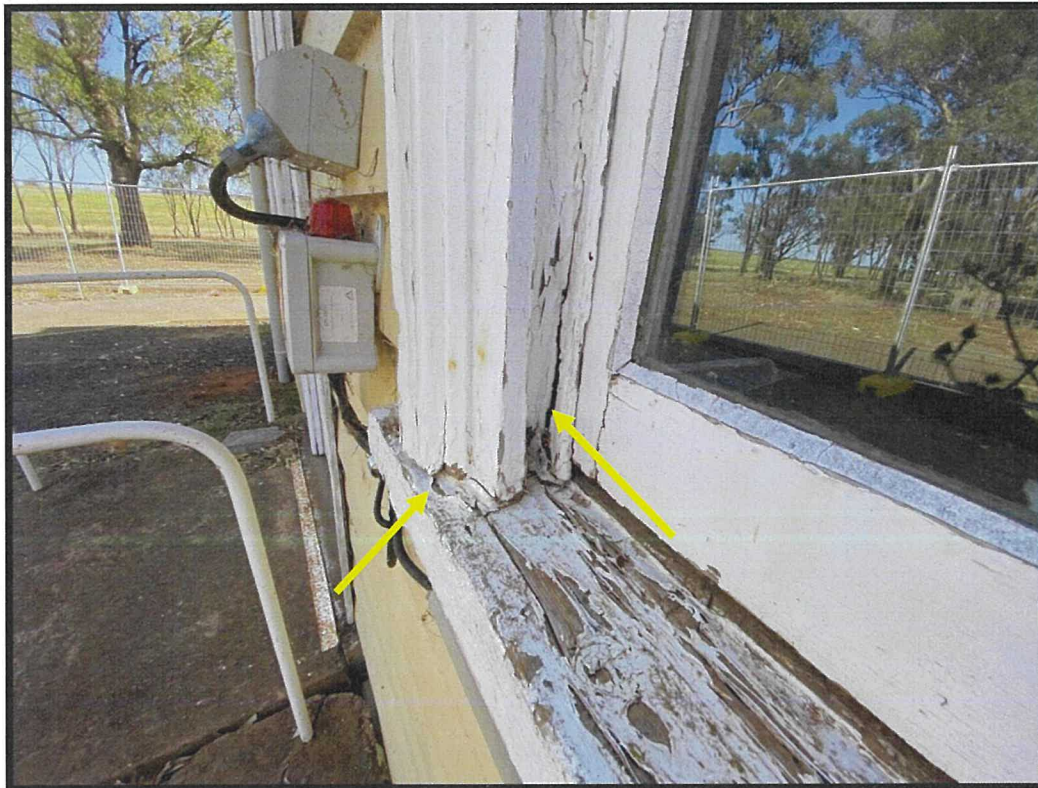
Photograph 5 – Typical dilapidation to the window frames along the building perimeter. Note the timber splitting and sealing dilapidation.

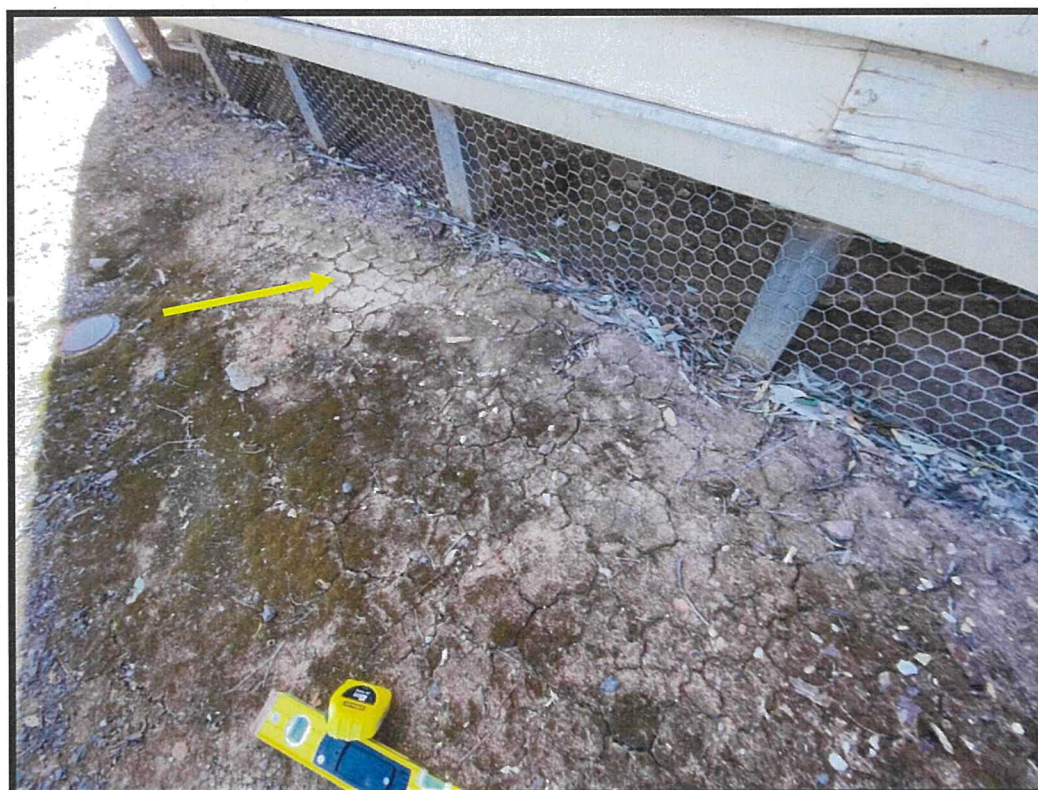
Photograph 6 – Typical cracked dried soil surface adjacent to the building perimeter.

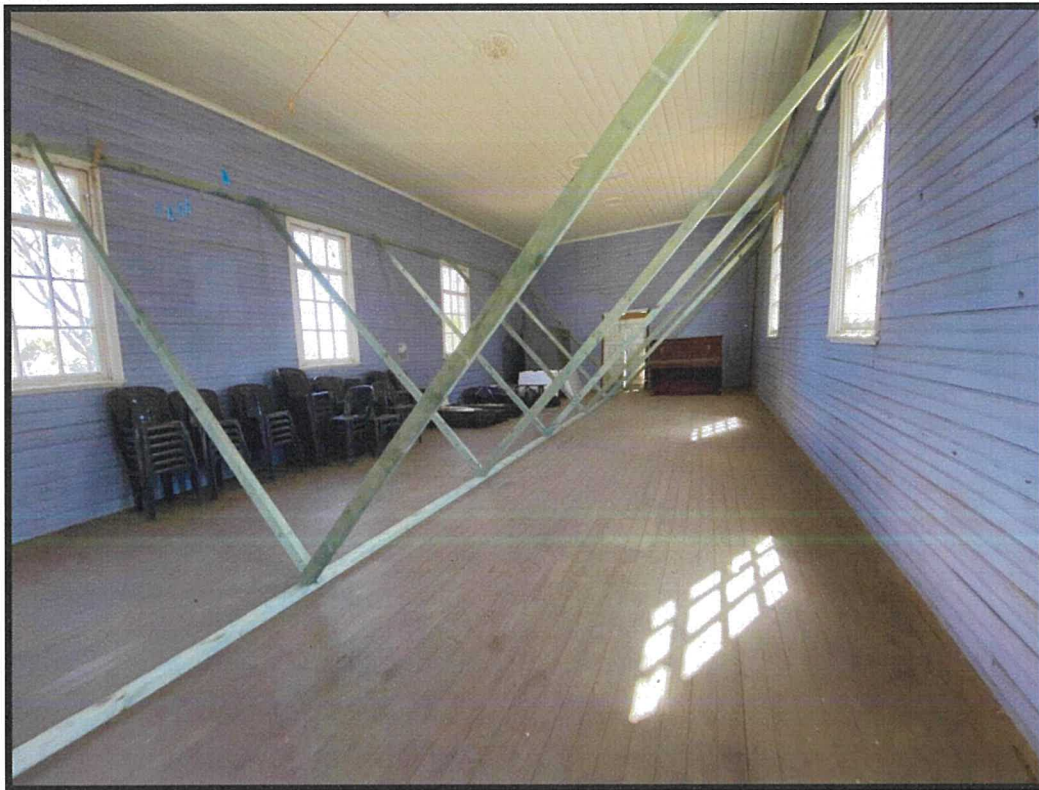
- The west end of the building is leaning towards the north by 3.2° (56mm/m) [7-9].
- Deformation of the western wall [8].
- Staining to some of the exposed timber studs of the western wall of the building [10-11].
- Detachment/misalignment of the internal lining boards of the wall on the east side of the stage [13].
- Detachment/misalignment of the internal lining boards of the northern wall [14].
- Pre-existing splitting to the internal lining boards of the northern wall [15].
- Detachment of the timber cornice and cracking to the ceiling boards on the north end of the hall [16].

Photograph 7 – The west end of the building is leaning towards the west by 3.2° (56mm/m). Temporary bracing has been installed as part of the make safe works.

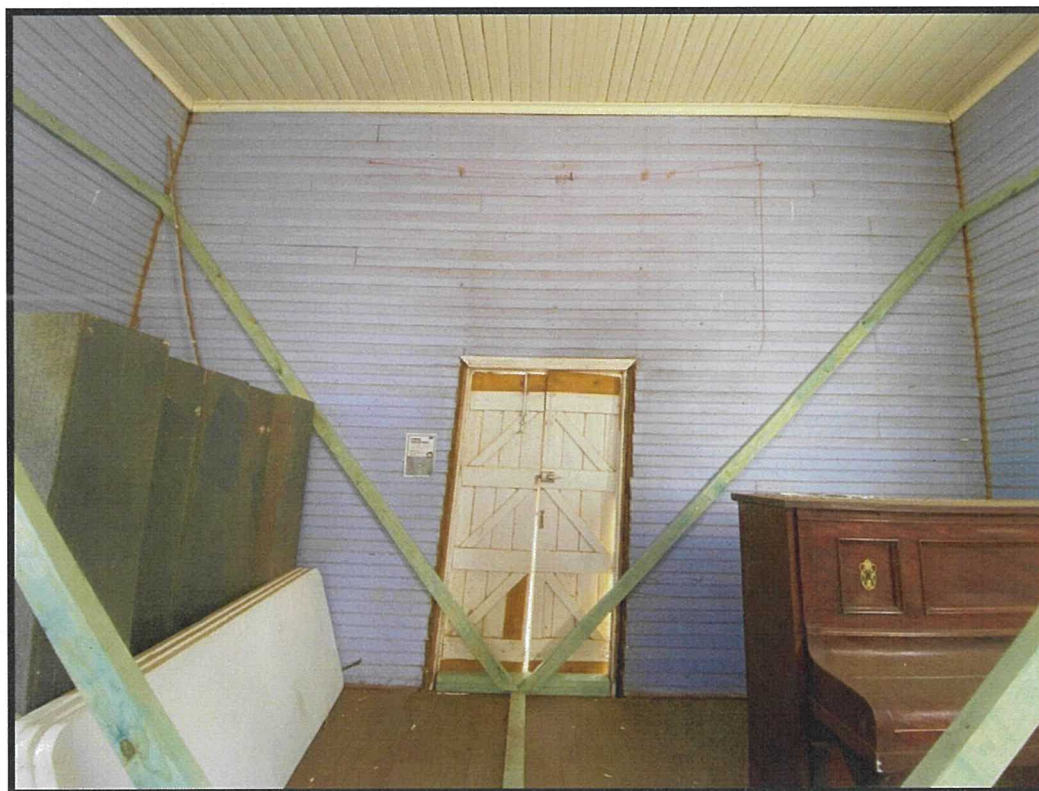
- 4.23 The inclination/leaning at west end of the building has resulted in a horizontal displacement at the top of the western wall of approximately 235mm towards the north. The displacement has resulted in significant deformation and damage to the western framed wall.
- 4.24 Note that there are no internal walls (or wall frames designed for portal action) in the south-north direction in the west half of the building. The bracing capacity of the western half of structure relied completely on the western wall which has been deformed and damaged. As such, the stability of the structure relies now on the temporary propping installed during the make-safe works.
- 4.25 Accordingly, the structural integrity and stability of the subject building has been compromised following the contributing wind event.

Photograph 8 – Deformation of the western wall.

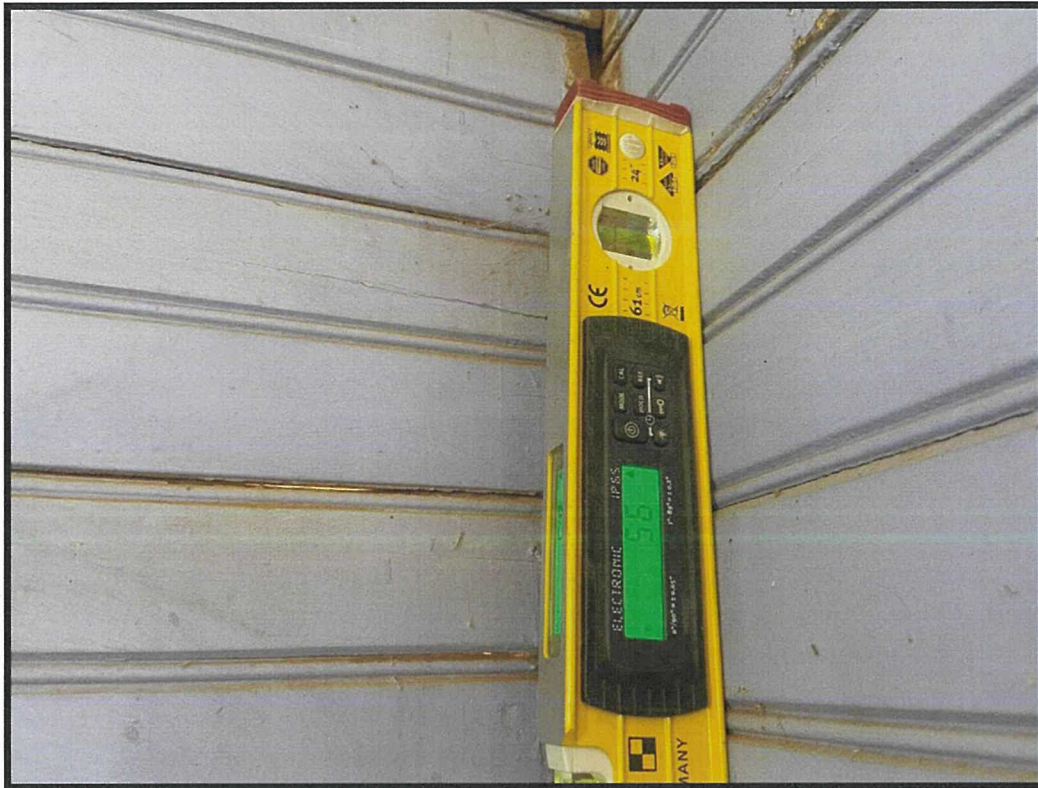
Photograph 9 – The west end of the building is leaning towards the north by 3.2° (56mm/m).

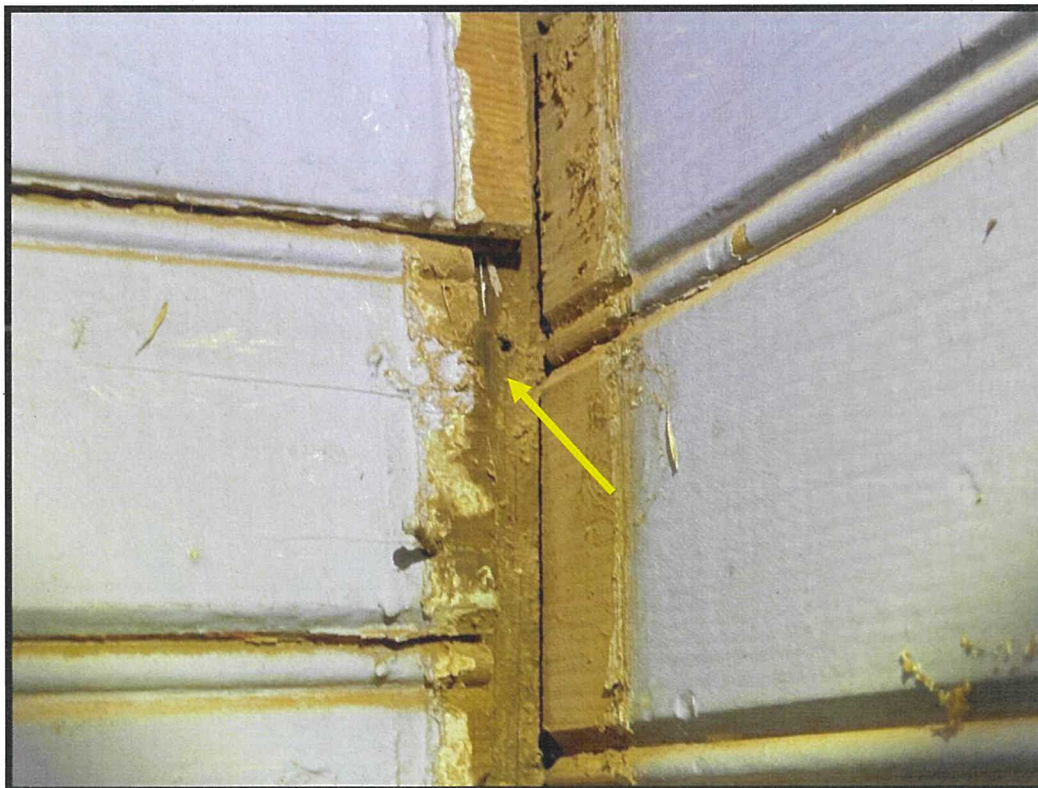
Photograph 10 – Minor staining to the exposed timber stud at the north end of the western wall of the building.

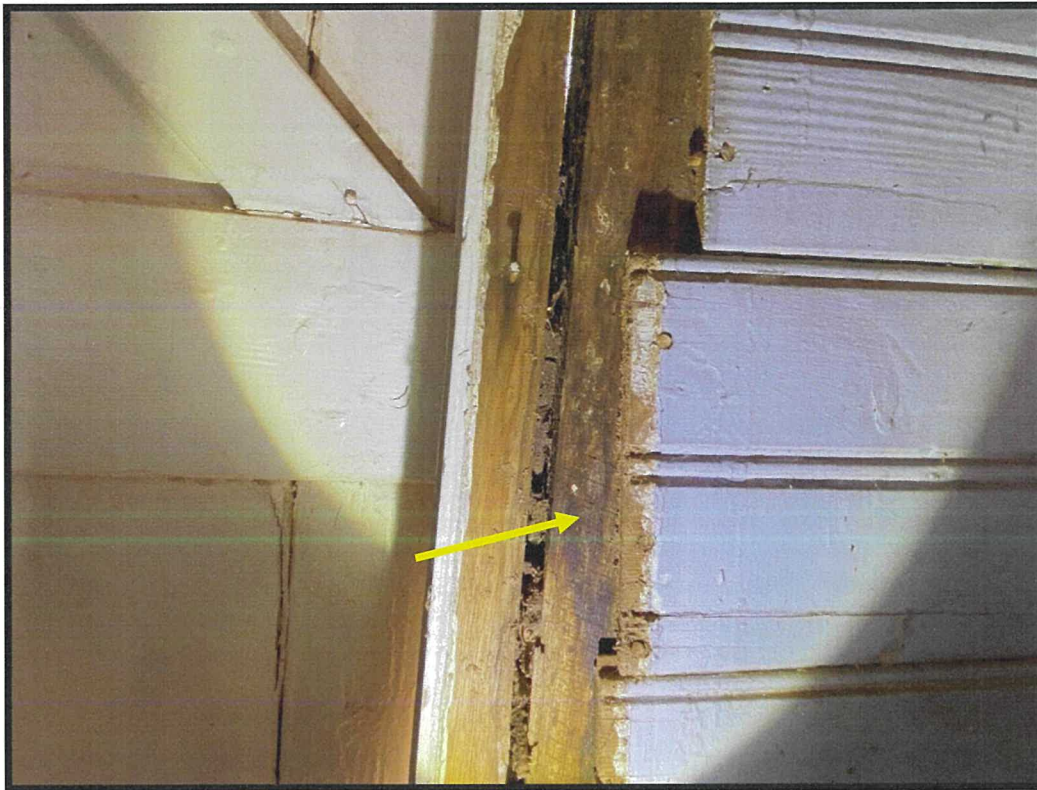
Photograph 11 – Staining to the exposed timber stud adjacent to the door frame of the on western wall of the building.

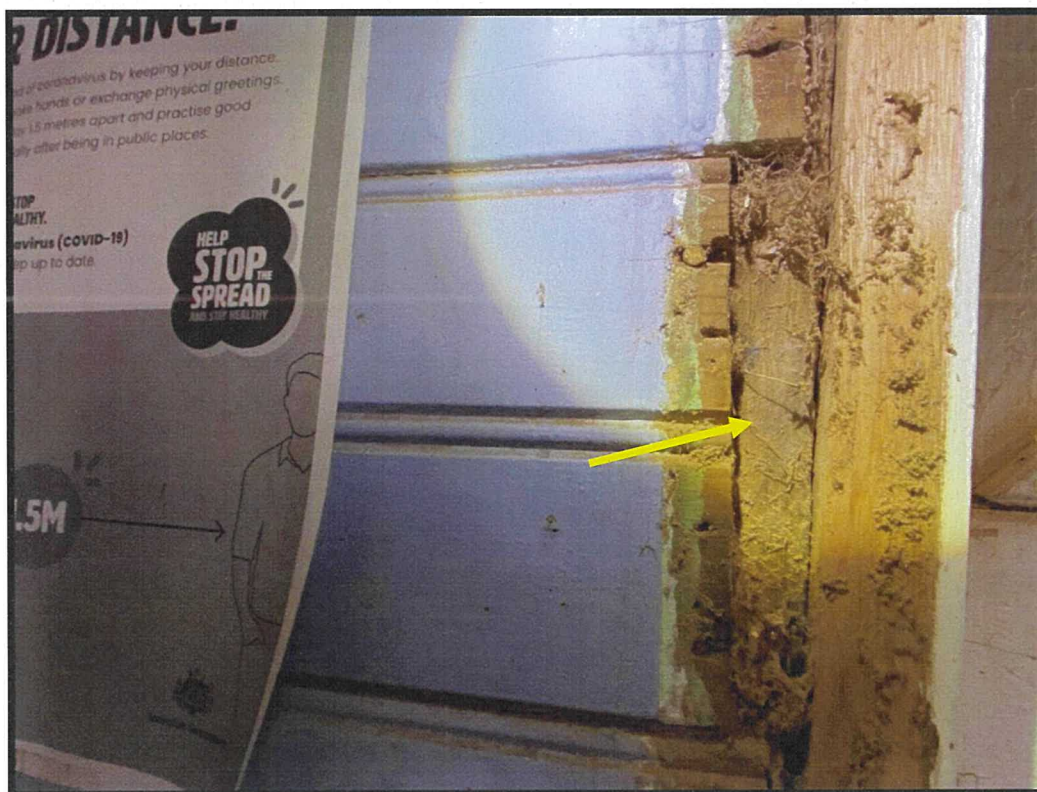
Photograph 12 – Exposed timber stud adjacent to the door frame of the on western wall of the building.

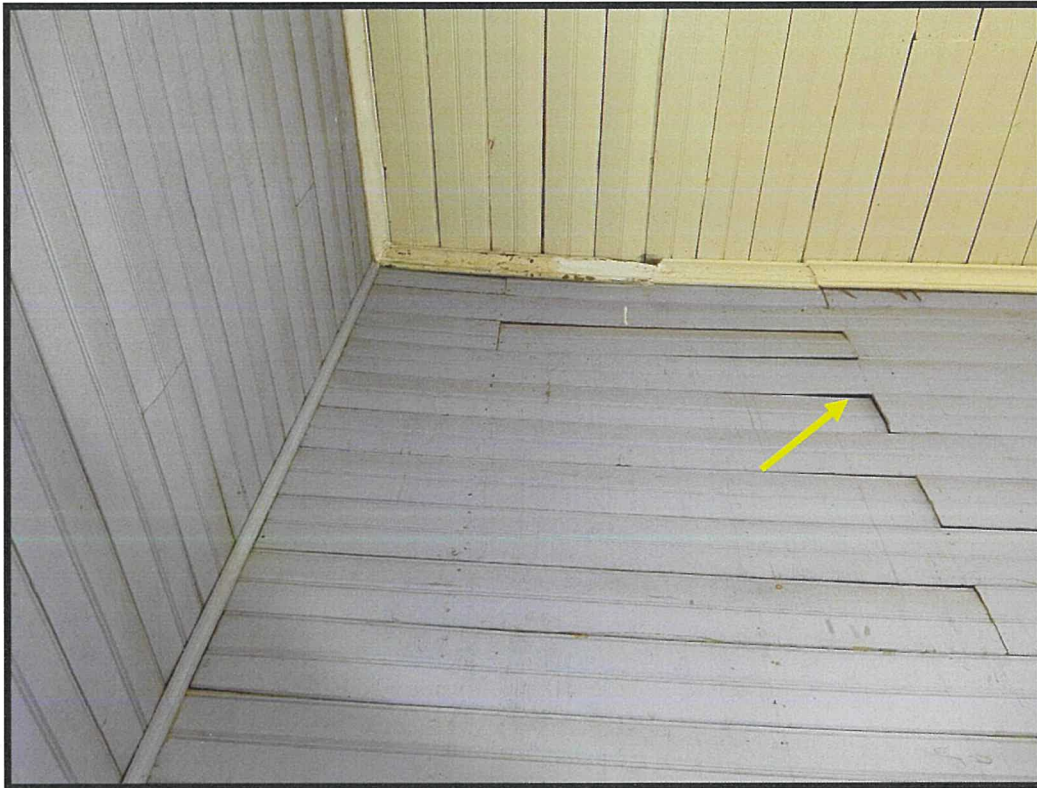
Photograph 13 – Typical detachment/misalignment of the internal lining boards of the wall on the east side of the stage.

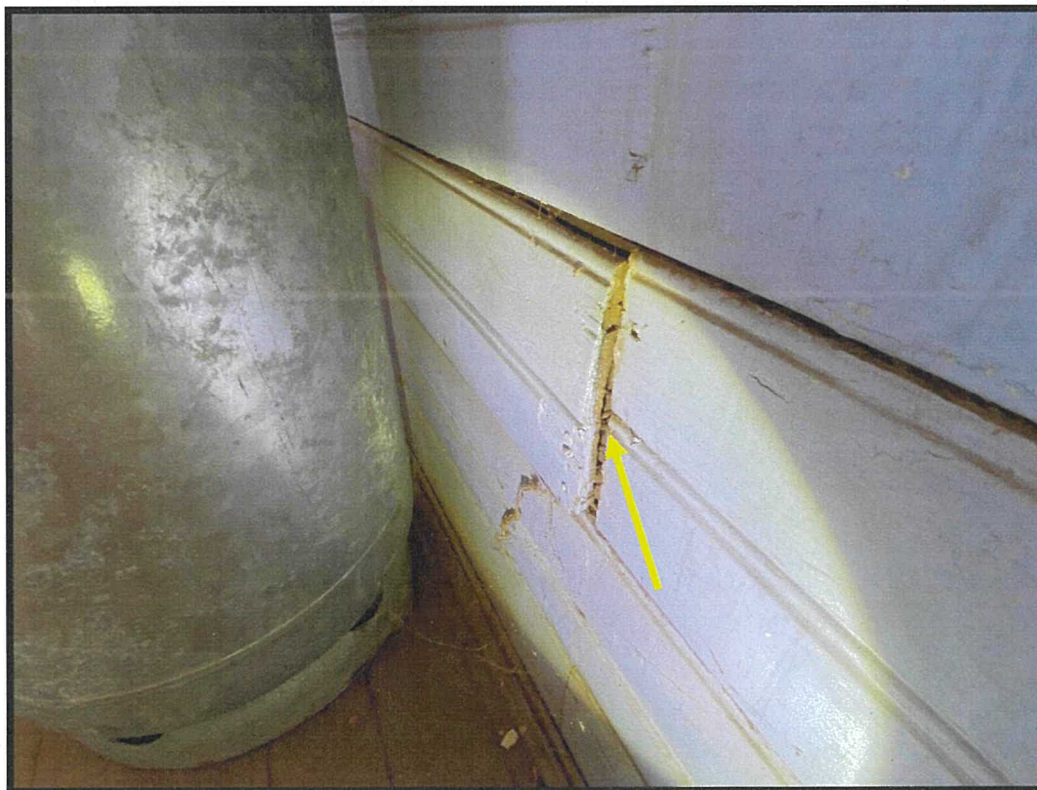
Photograph 14 – Typical detachment/misalignment of the internal lining boards of the northern wall.

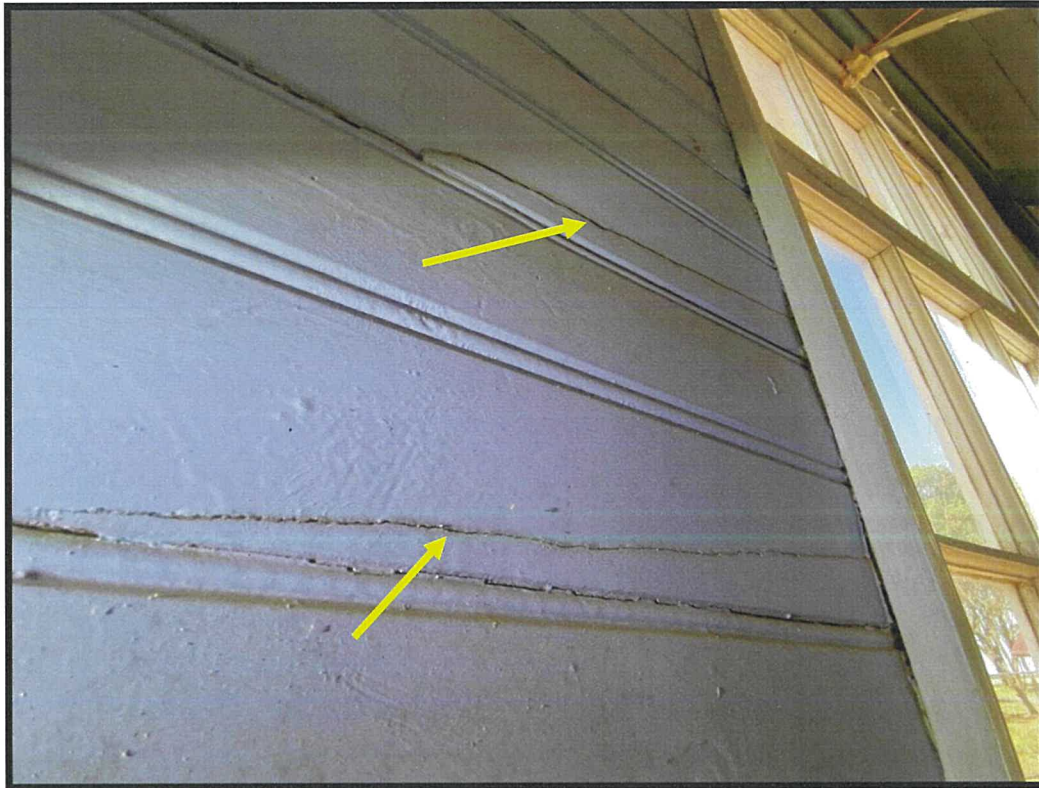
Photograph 15 – Typical pre-existing splitting to the internal lining boards of the northern wall.

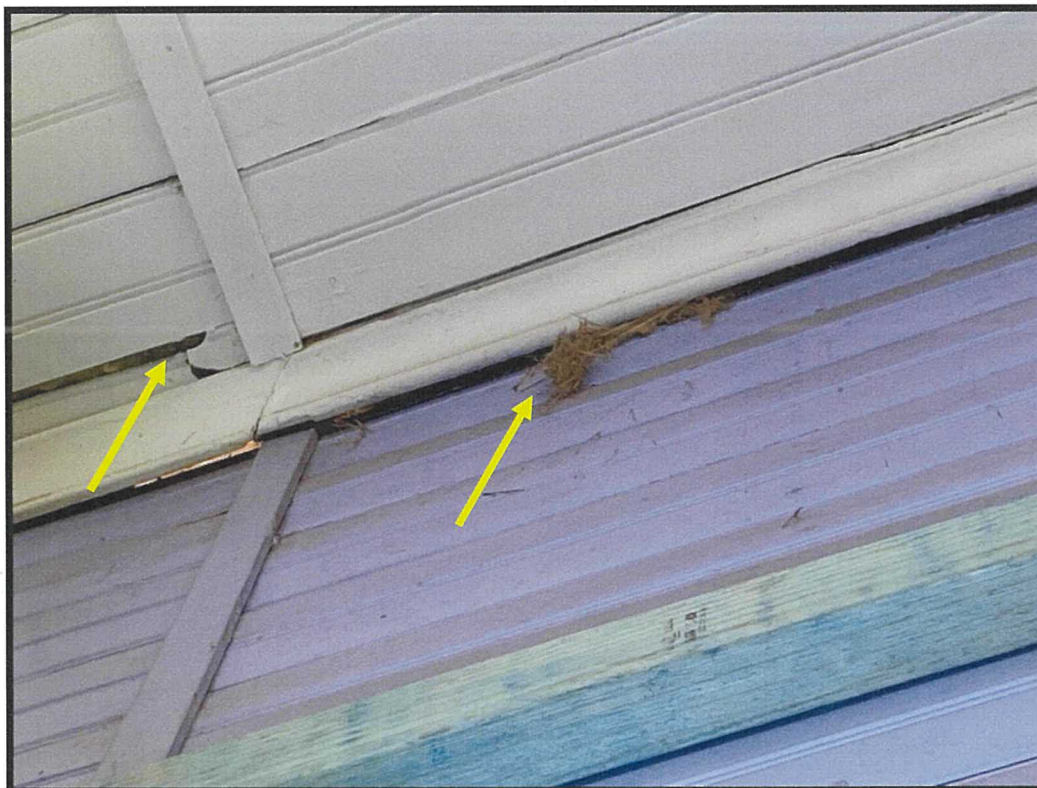
Photograph 16 – Detachment of the timber cornice and cracking to the ceiling boards on the north end of the hall.

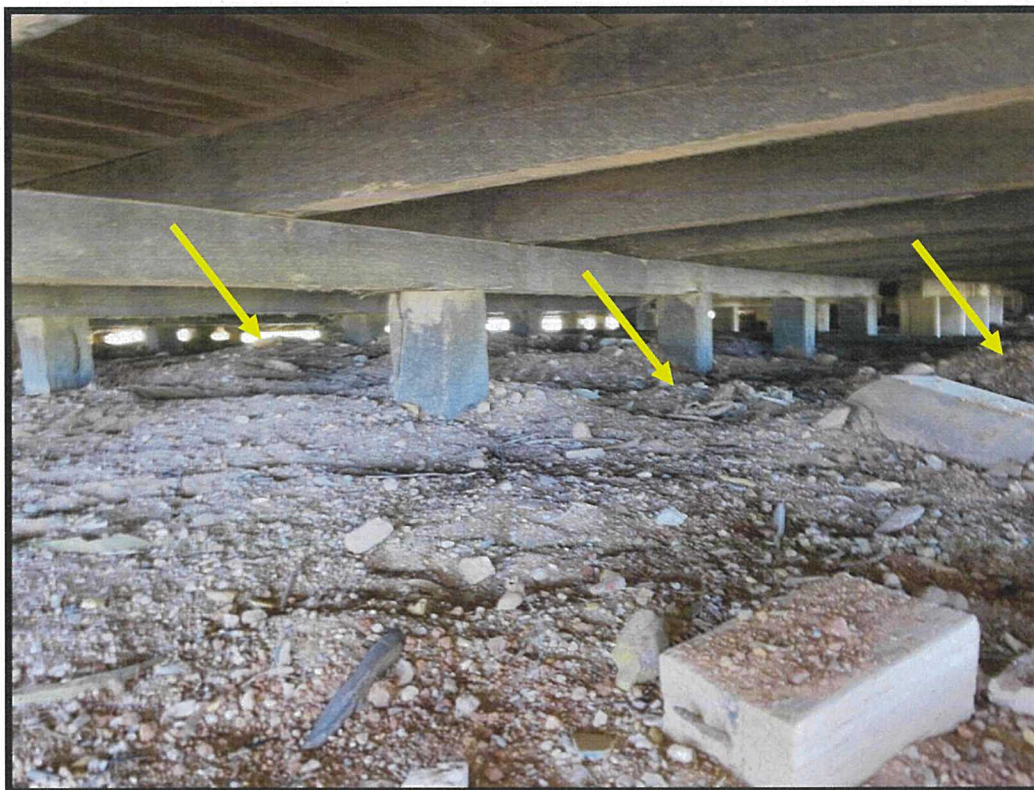
Photograph 17 – Variation of ground surface levels in the subfloor space.

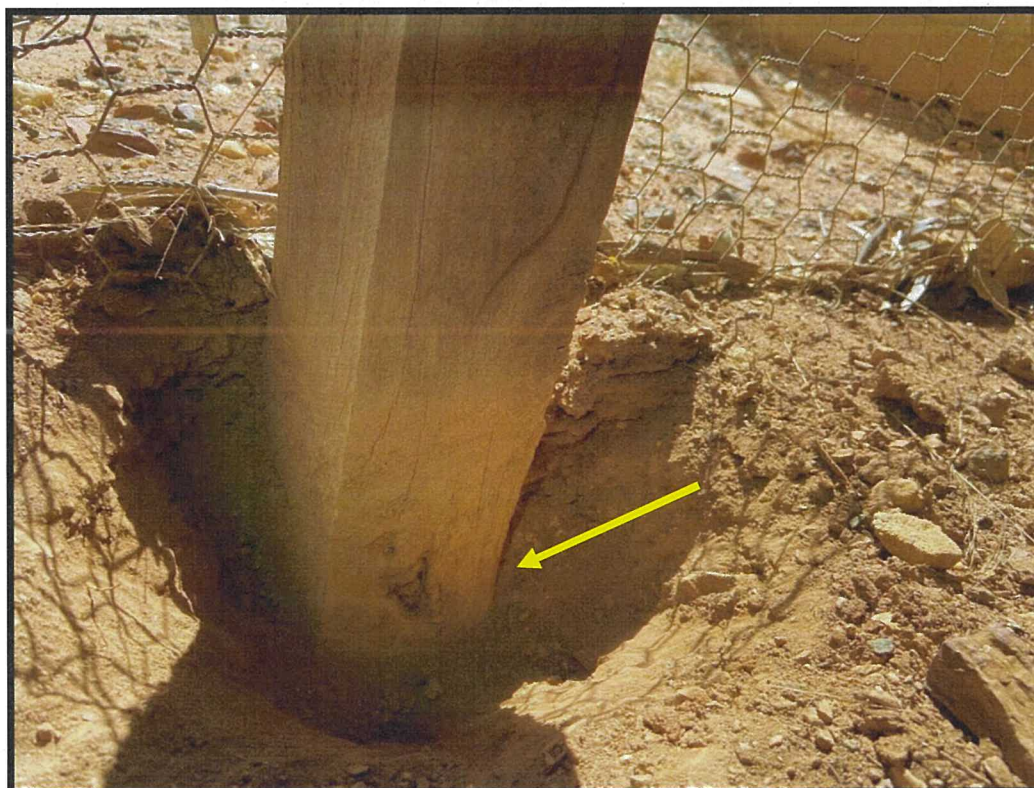
- 4.2 With respect to the condition of the timber stumps, a visual inspection of some of the perimeter an internal timber stumps indicates minor decay and loss of material evident below the sub-floor surface. The observed decay and loss of material has occurred over many years and is not the result of a single one-off event. Note that perimeter stumps were replaced circa 2010 following the observation of damage (to the timber stumps) during building inspections conducted by [REDACTED]
- 4.3 The lack of adequate impervious paving around the building and the lack of adequate graded surface drainage in the subfloor space have facilitated water pooling around the stumps during several rainfall events contributing to the observed damage to the timber stumps.

Photograph 18 – Loss of material to a perimeter timber stump.

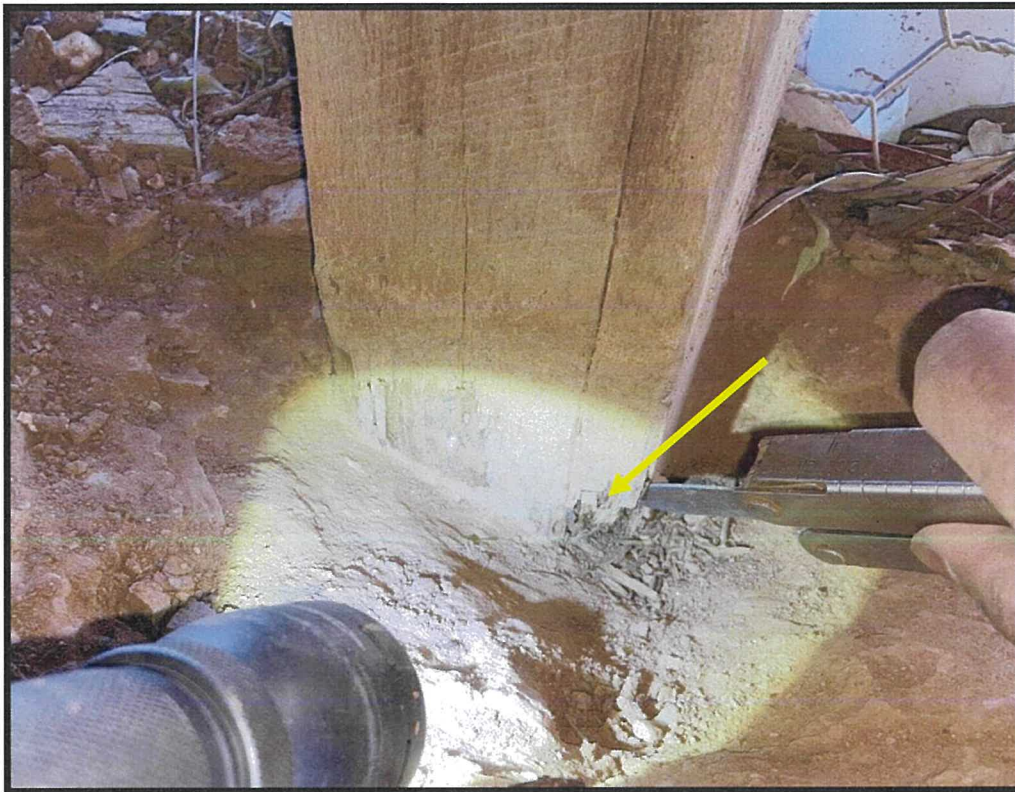
Photograph 19 – Decay to a perimeter timber stump.

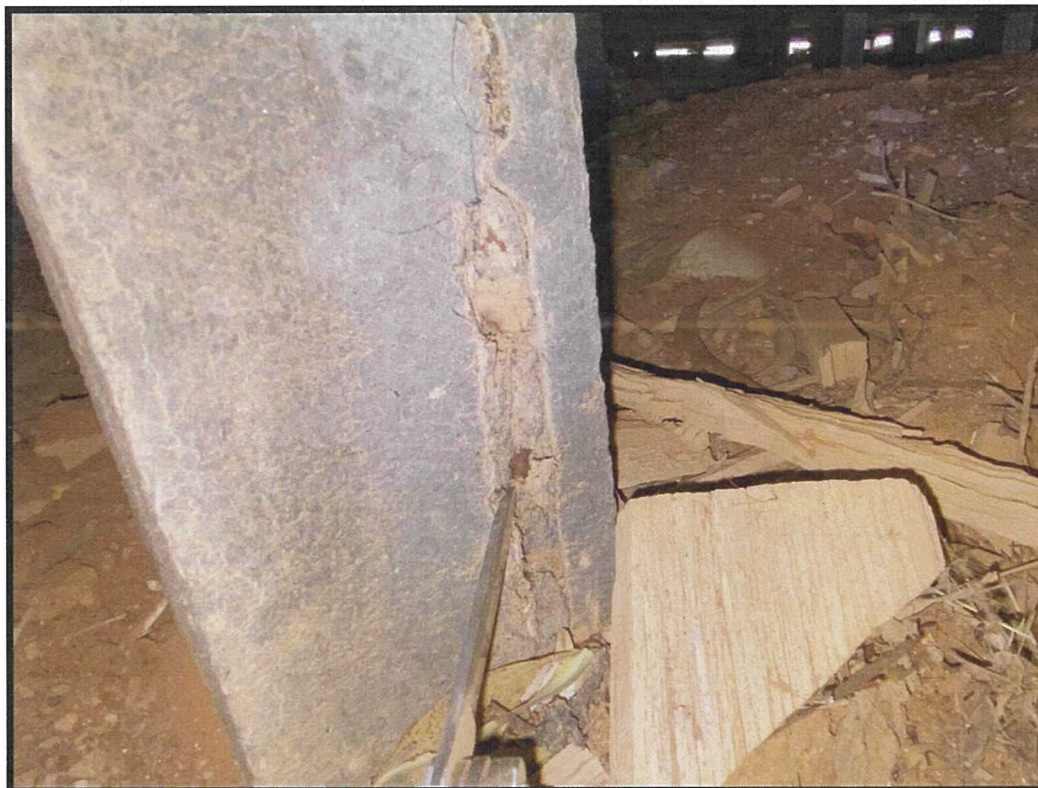
Photograph 20 – Minor decay to an internal timber stump.
