# Engineering investigation report

Kamarooka Hall, 420 Kamarooka Store Road, KAMAROOKA, VIC 3570

## 1.0 Introduction

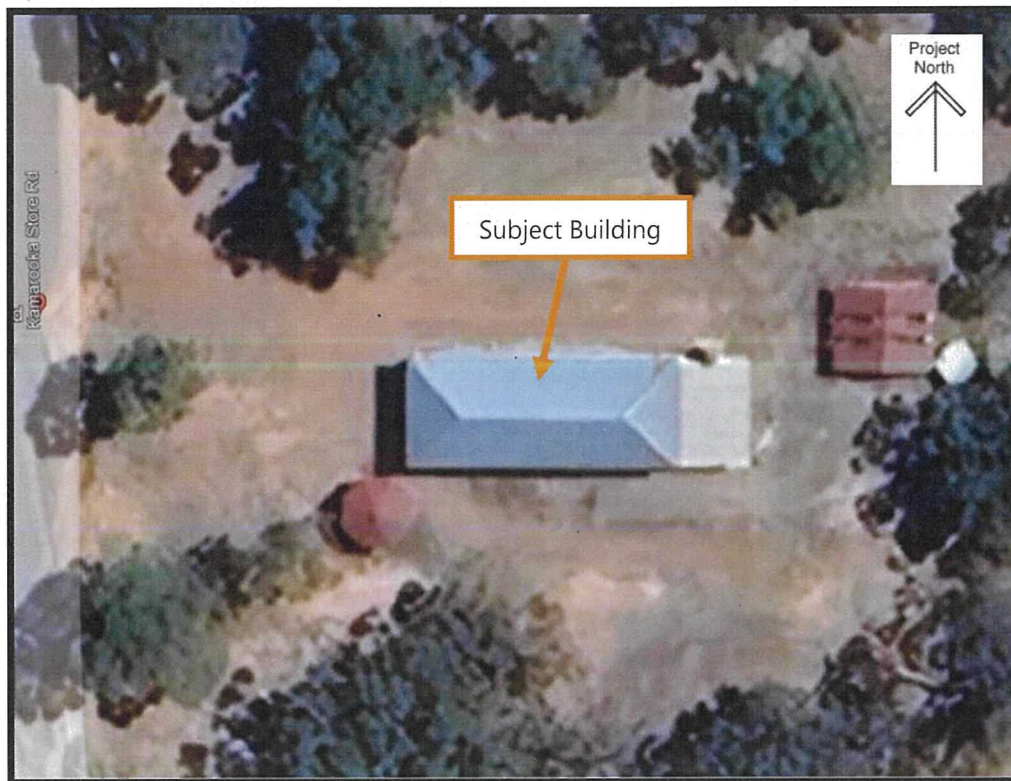
Figure 2.1 - Google Earth aerial photograph dated November 2022. Note the trees in relatively close proximity to the building.

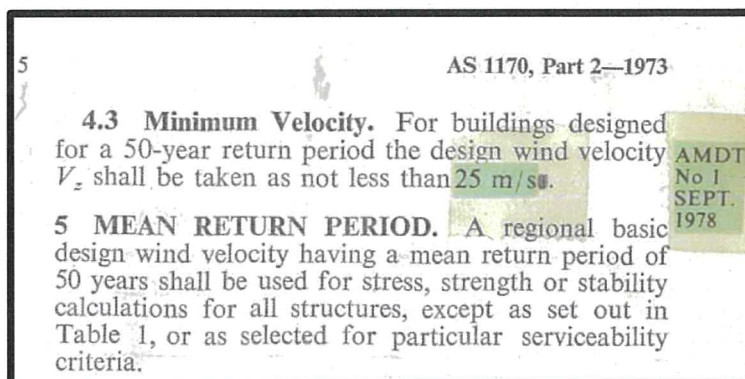
- 4.12 Regarding the design wind velocity, the minimum design wind velocity for buildings designed for a 50-year return period specified in AS 1170, Part 2—1973 was 25m/s; refer to Figure 4.1.

Figure 4.1 - Extract from AS 1170, Part 2 – 1973 showing the minimum wind design velocity as 25 m/s.

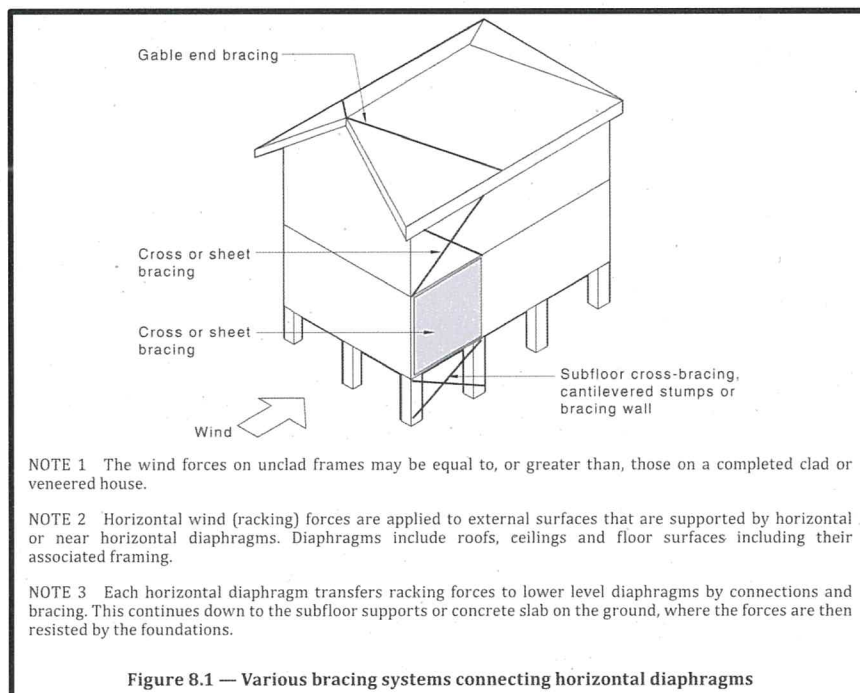
Figure 4.2 - Extract from AS 1684.2:2021 showing the bracing systems connecting horizontal diaphragms.

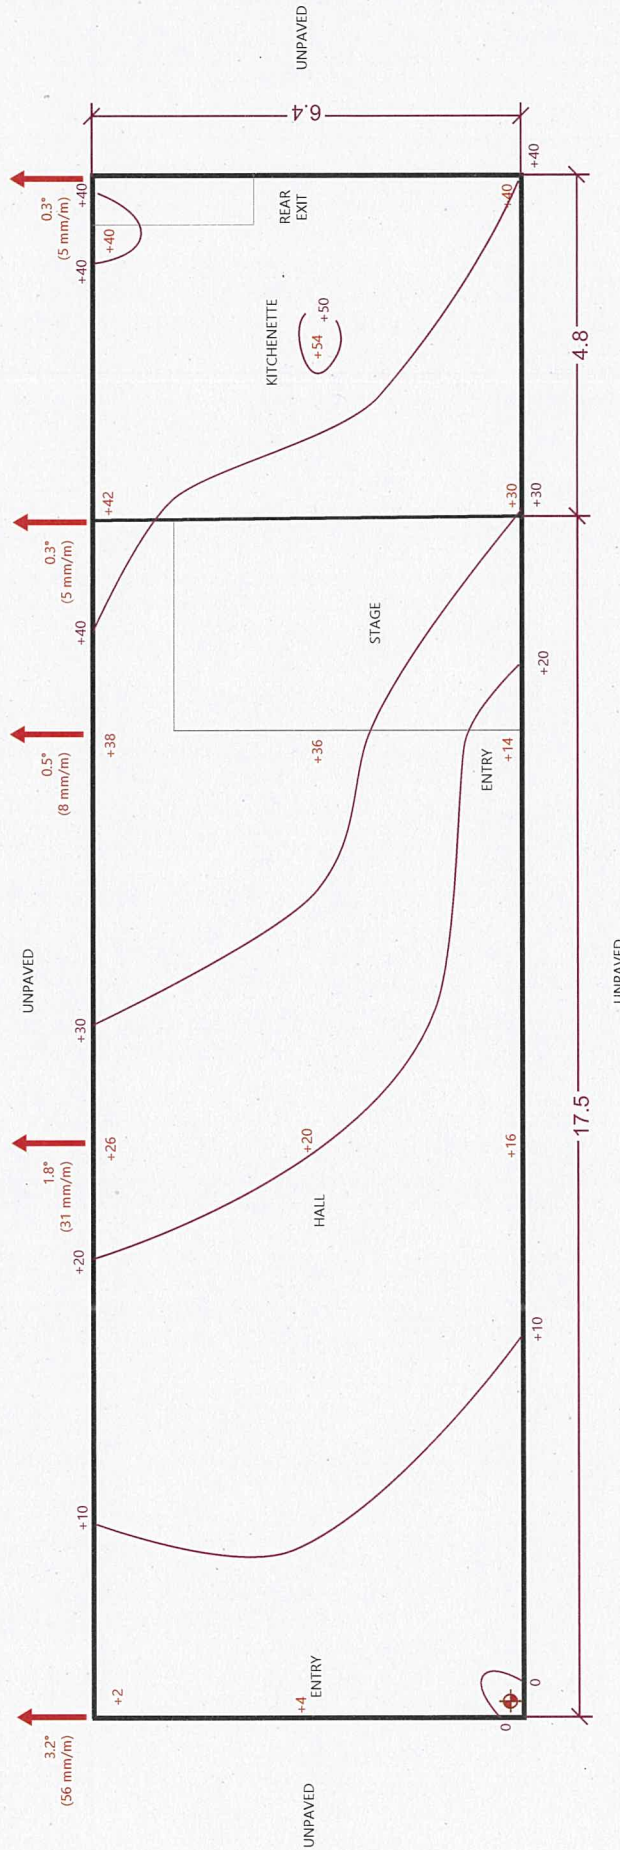
HEIGHT OF PERIMETER WALLS: 4.2m

DIRECTION OF BUILDING INCLINATION/LEANING
